**ODFW AQUATIC INVENTORY PROJECT  
RESTORATION MONITORING  
STREAM HABITAT REPORT**

STREAM: BIG ELK CREEK SITE 3  
 GCG: 2-MC  
 SITE ID: 401  
 BASIN: YAQUINA  
 TREATMENT DATE: 2008  
 SURVEY DATE: 1/26/2009  
 SURVEY CREW: Matt Strickland / Charlie Stein  
 USGS MAPS: HARLAN  
 ECOREGION: Mid-Coastal Sedimentary  
 REPORT PREPARED BY: Matt Strickland / Sharon Tippery / Charles Stein

REACH: 1 LOCATION: T12S-R09W-S02SE

**Big Elk Creek Site 3 (MC-401) 2009 Winter Habitat Survey Photographs**

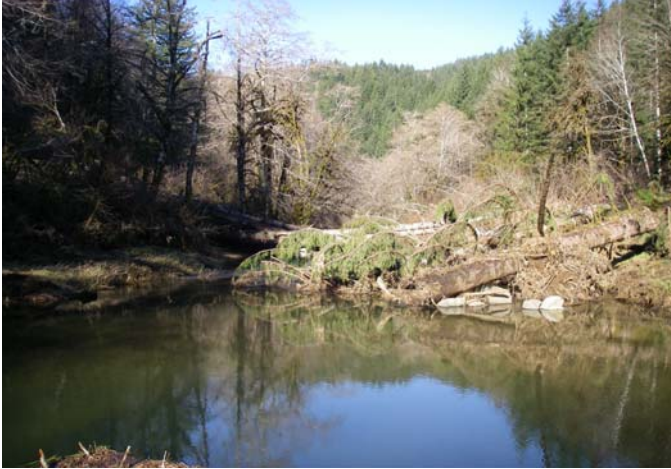
Unit 1 - Downstream view of placed large wood and boulders.

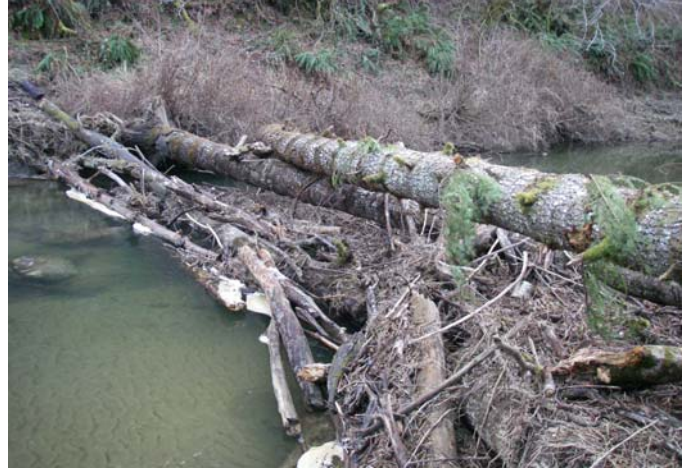
Unit 1 - Large wood placement with debris accumulation.

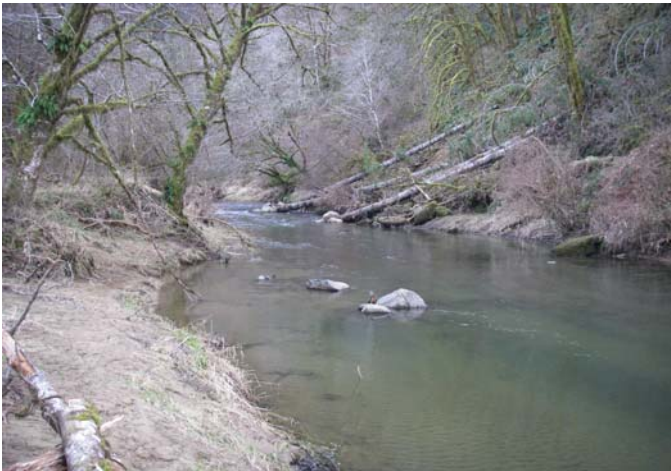
Unit 2 - Upstream view of reach.

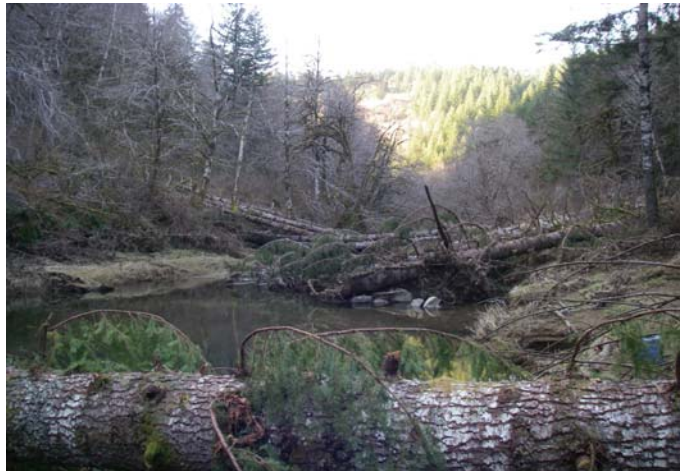
Unit 2 - Large wood placement.

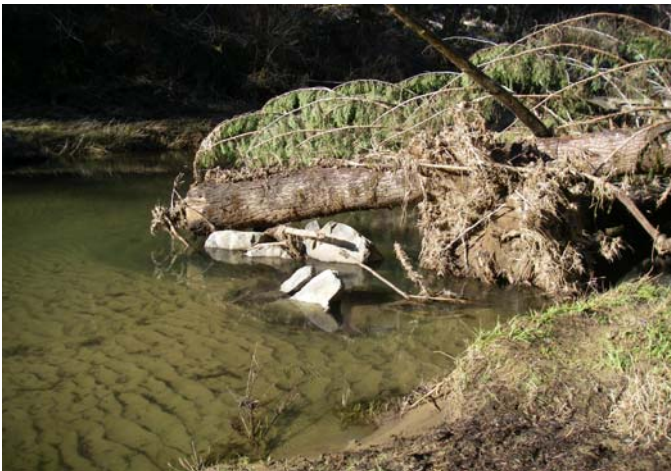
Sediment accumulation.

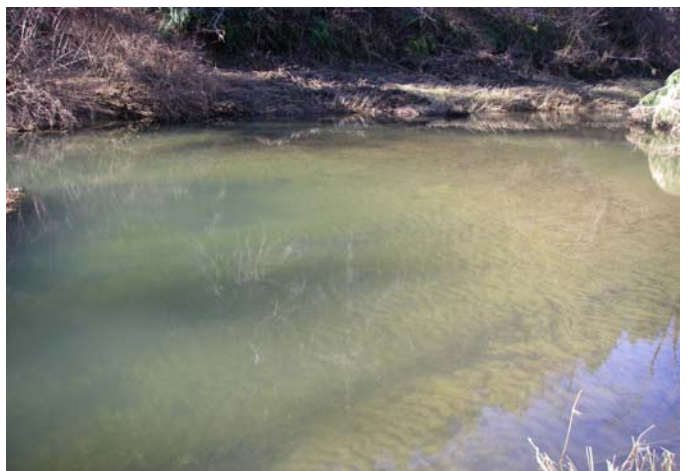
Sediment accumulation.
