**ODFW AQUATIC INVENTORY PROJECT
RESTORATION MONITORING
STREAM HABITAT REPORT**

STREAM: BUMMER CREEK
 GCG: 2-MC
 SITE ID: 9
 BASIN: ALSEA
 TREATMENT DATE: 2002
 SURVEY DATE: 1/6/2009
 SURVEY CREW: Sharon Tippery / Miles Johnson / Charlie Stein
 USGS MAPS: PRAIRIE PEAK
 ECOREGION: Mid-Coastal Sedimentary
 REPORT PREPARED BY: Matt Strickland / Sharon Tippery / Charles Stein

REACH: 1 LOCATION: T14S-R08W-S25SE

Bummer Creek (MC-9) 2009 Winter Habitat Survey Photographs

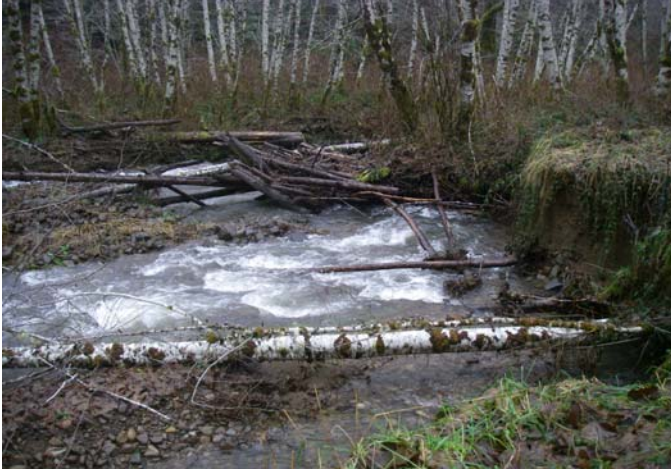
A downstream view of a debris jam.

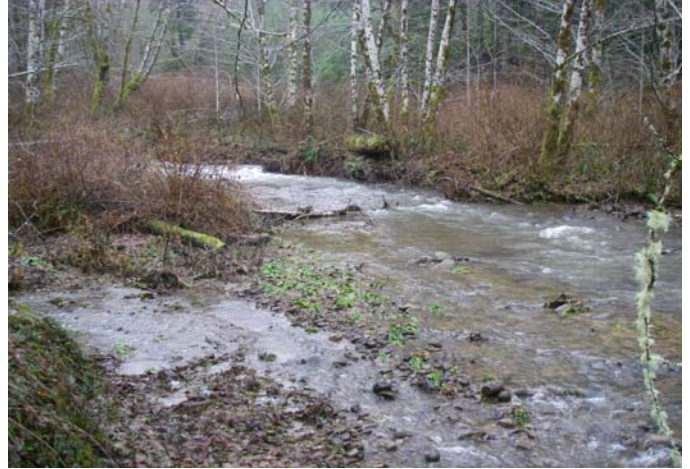
Looking upstream with secondary channel.

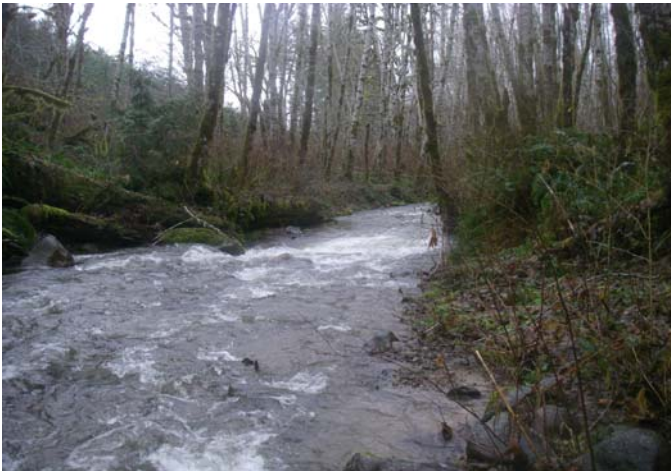
Looking downstream with view of pre-existing large wood.
