**ODFW AQUATIC INVENTORY PROJECT  
RESTORATION MONITORING  
STREAM HABITAT REPORT**

STREAM: SWANSON CREEK  
 GCG: 5-SC  
 SITE ID: 148  
 BASIN: FLORAS  
 TREATMENT DATE: 2002  
 SURVEY DATE: 3/31/2009  
 SURVEY CREW: David Jones / Ryan Emig  
 USGS MAPS: SIXES, LANGLOIS  
 ECOREGION: Coastal Lowlands  
 REPORT PREPARED BY: Matt Strickland / Sharon Tippery / Charles Stein

REACH: 1 LOCATION: T31S-R15W-S22NW

Swanson Creek (SC-148) 2009 Winter Habitat Survey Photographs

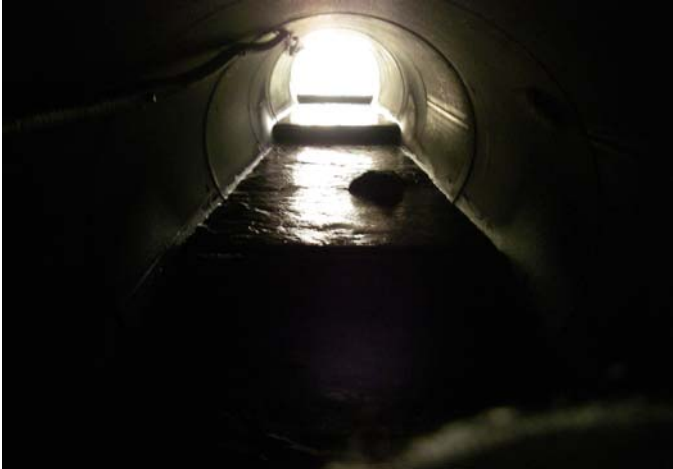
Unit 1 - Upstream view of Hwy. 101 culvert at start of survey. Hwy. 101 crosses here.

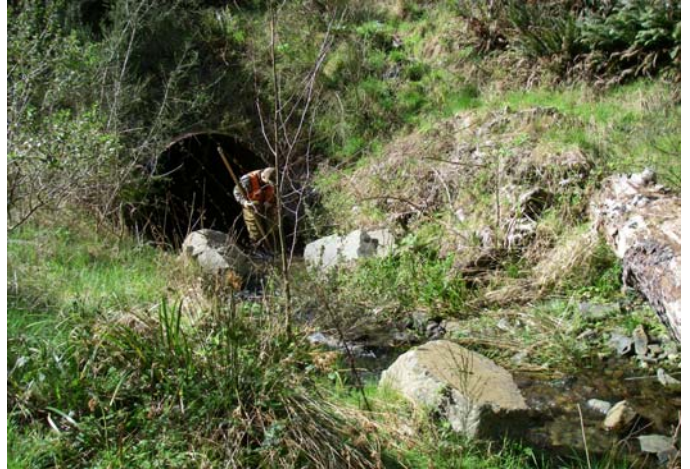
Unit 2 - Downstream view of upstream end of Hwy. 101 culvert.

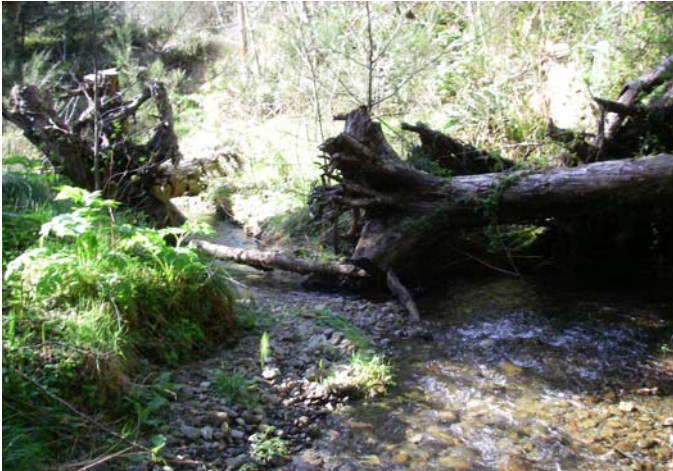
Downstream view of placed logs habitat structure.

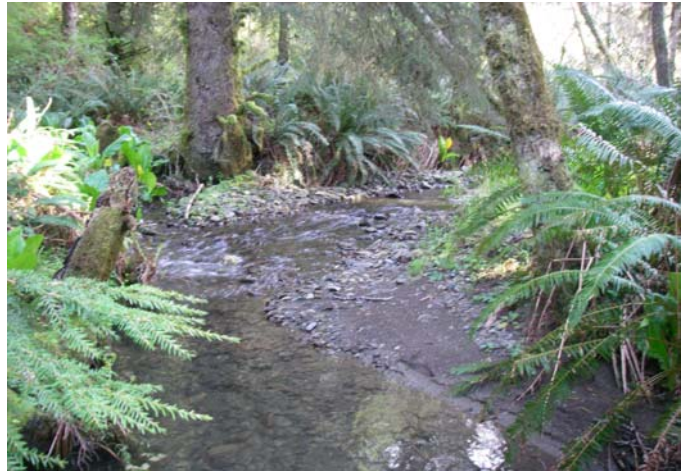
Upstream view of Pea Creek reach.

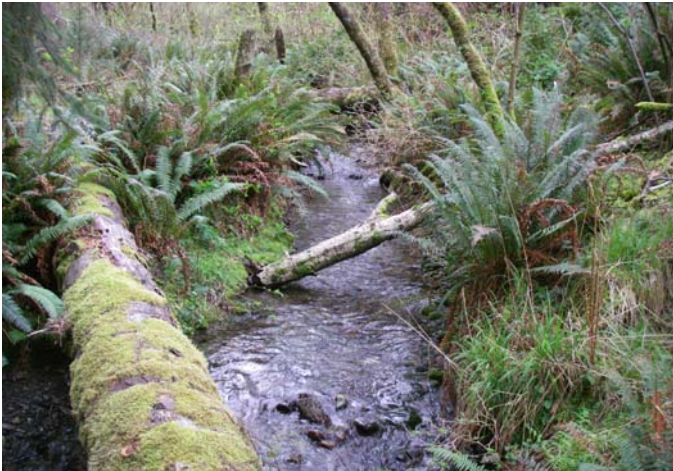
Upstream view of Pea Creek reach near end of survey.

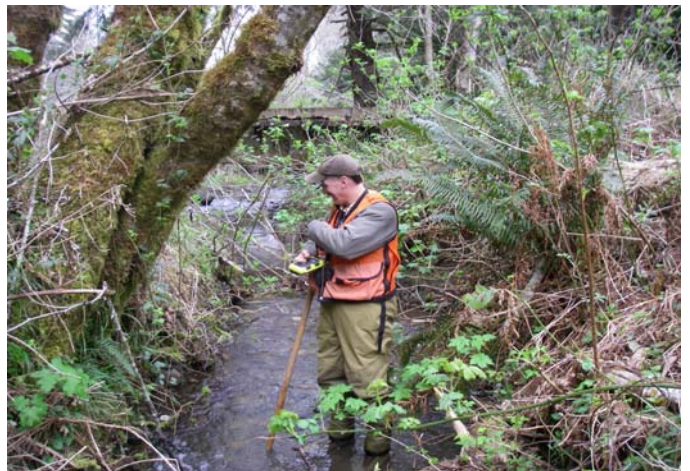
Downstream view of stream at the end of the survey. Second bridge in background.
