**ODFW AQUATIC INVENTORY PROJECT
RESTORATION MONITORING
STREAM HABITAT REPORT**

STREAM: EDSON CREEK LOWER
 GCG: 5-SC
 SITE ID: 135
 BASIN: ROGUE
 TREATMENT DATE: 2002
 SURVEY DATE: 3/31/2009
 SURVEY CREW: David Jones / Ryan Emig
 USGS MAPS: GOLD BEACH
 ECOREGION: Coastal Uplands
 REPORT PREPARED BY: Matt Strickland / Sharon Tippery / Charles Stein

Edson Creek Lower (SC-135) 2009 Winter Habitat Survey Photographs

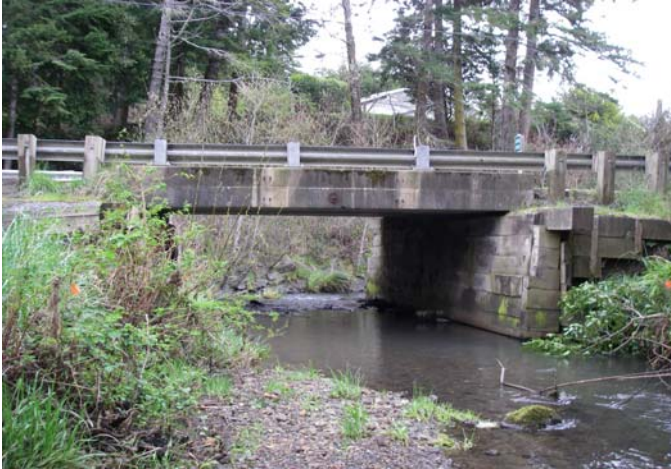
Downstream view of county bridge near start of survey.
Edson Creek Road crosses here.

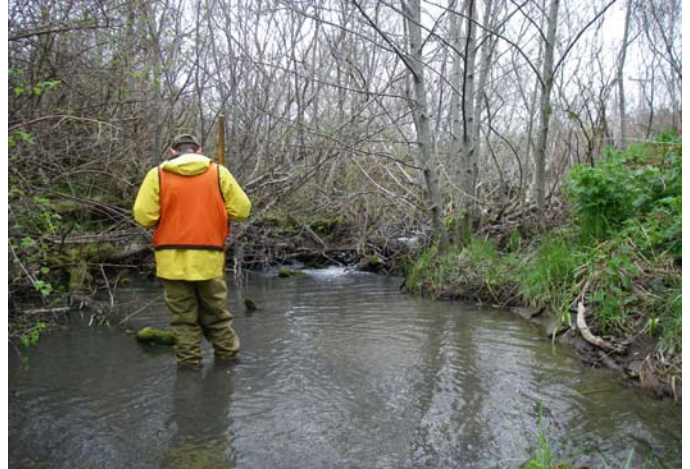
Upstream view of riparian area.

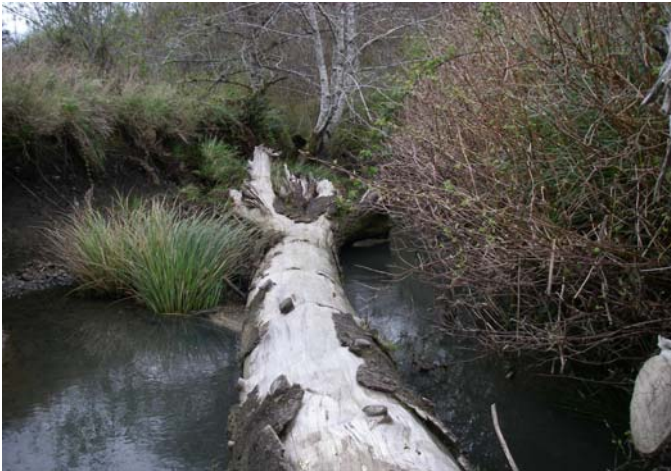
Downstream view of placed log habitat structure.

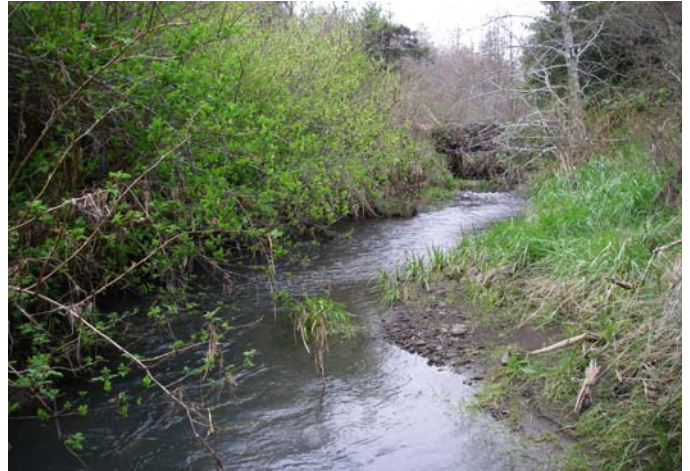
Upstream view of reach with large wood placement in background.

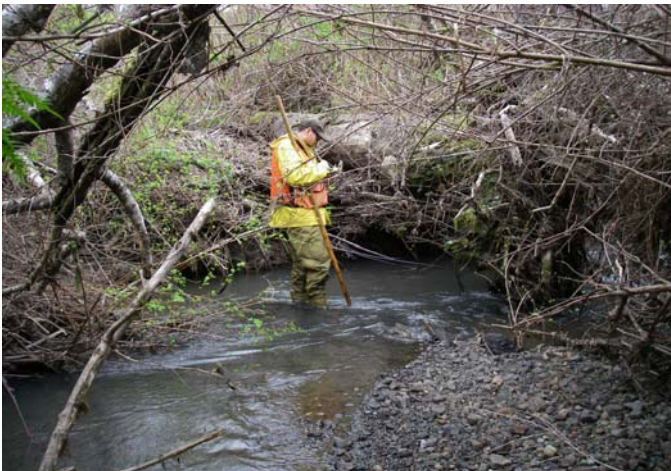
Downstream view of large wood placement.

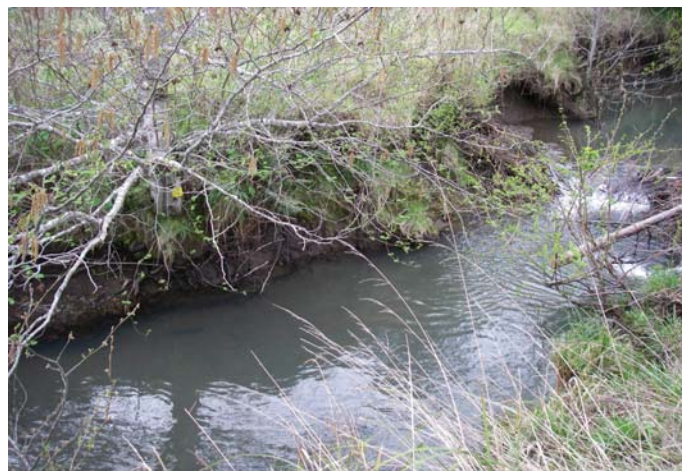
View of right bank tributary at the end of the survey.
