**ODFW AQUATIC INVENTORY PROJECT
RESTORATION MONITORING
STREAM HABITAT REPORT**

STREAM: DIETZ CREEK
 GCG: 1-NC
 SITE ID: 134
 BASIN: KILCHIS
 TREATMENT DATE: 2003
 SURVEY DATE: 4/21/2009
 SURVEY CREW: Ryan Jacobsen / Miles Johnson
 USGS MAPS: KILCHIS RIVER
 ECOREGION: Volcanics
 REPORT PREPARED BY: Matt Strickland / Sharon Tippery / Charles Stein

REACH: 1 LOCATION: T01S-R09W-S23NW

Dietz Creek (NC-134) 2009 Winter Habitat Survey Photographs

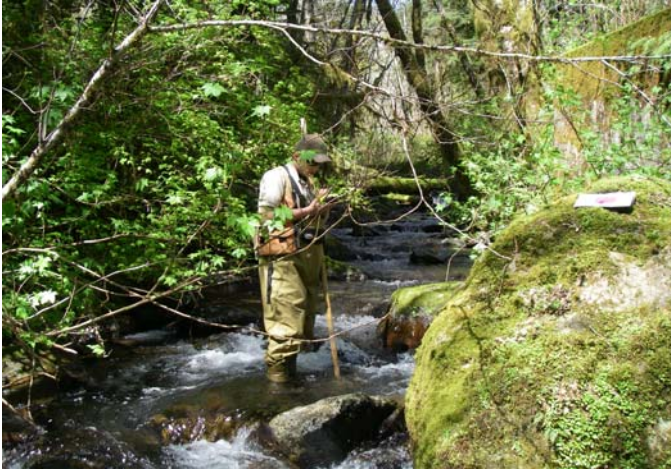
Unit 1 - Upstream view of the Dietz Creek survey start.

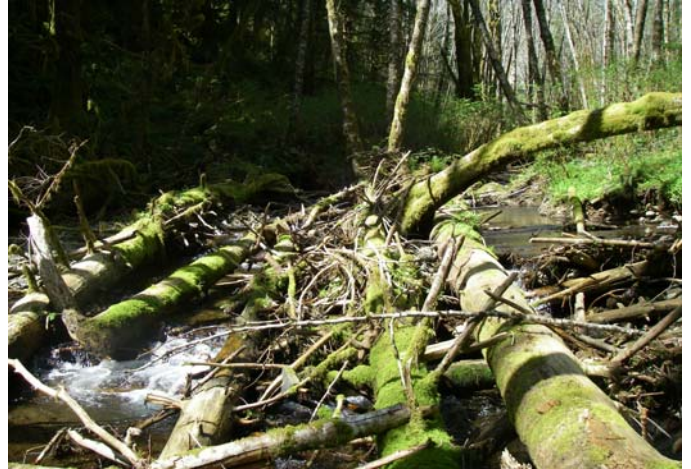
Unit 13 - Looking upstream at a habitat structure with debris accumulation.

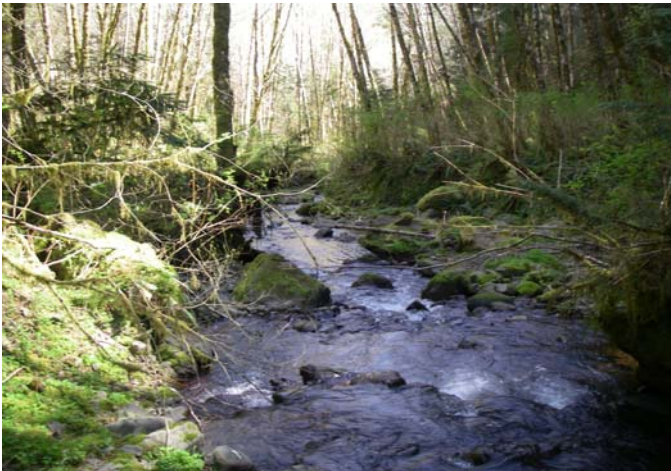
Unit 32 - Downstream view of cascade over boulders.

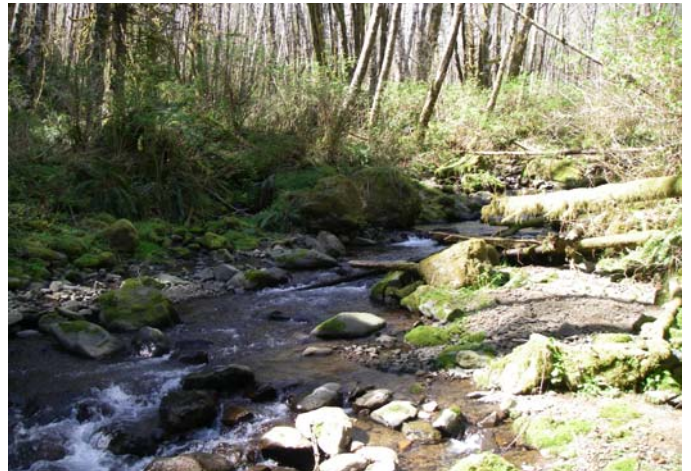
Unit 33 - Upstream view of cascade over boulders.

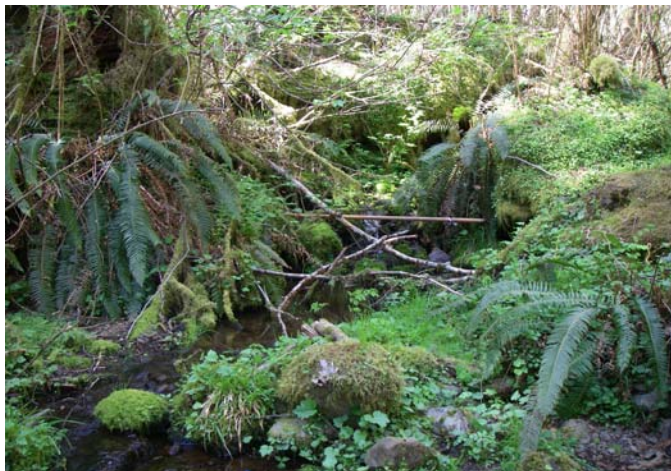
Unit 35 - Small tributary.

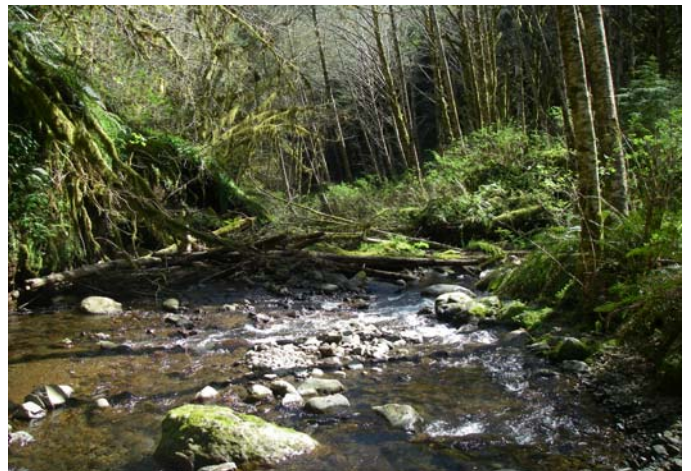
Unit 39 - Downstream view of the end of the survey.
