**ODFW AQUATIC INVENTORY PROJECT
RESTORATION MONITORING
STREAM HABITAT REPORT**

STREAM: BAYS CREEK
 GCG: 1-NC
 SITE ID: 3
 BASIN: NESTUCCA
 TREATMENT DATE: 2003
 SURVEY DATE: 3/27/2009
 SURVEY CREW: Ryan Jacobsen / Miles Johnson
 USGS MAPS: BLAINE
 ECOREGION: Volcanics
 REPORT PREPARED BY: Matt Strickland / Sharon Tippery / Charles Stein

Bays Creek (NC-3) 2009 Winter Habitat Survey Photographs

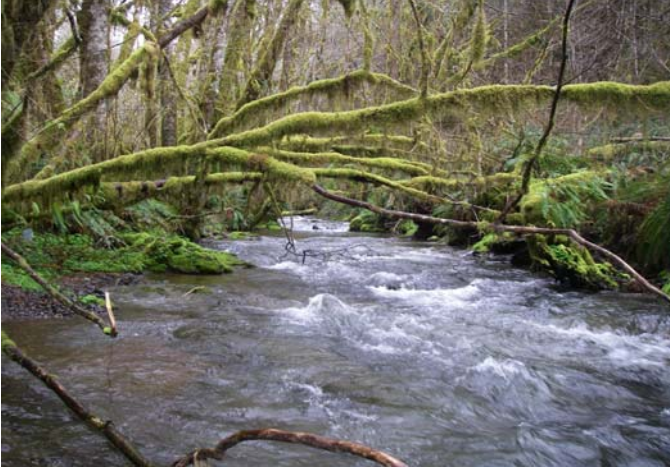
Unit 1 - Upstream view at start of survey.

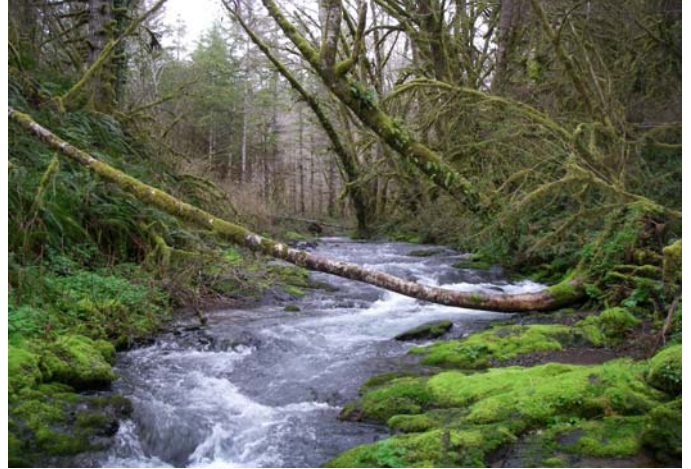
Unit 8 - Looking upstream at a bedrock rapid.

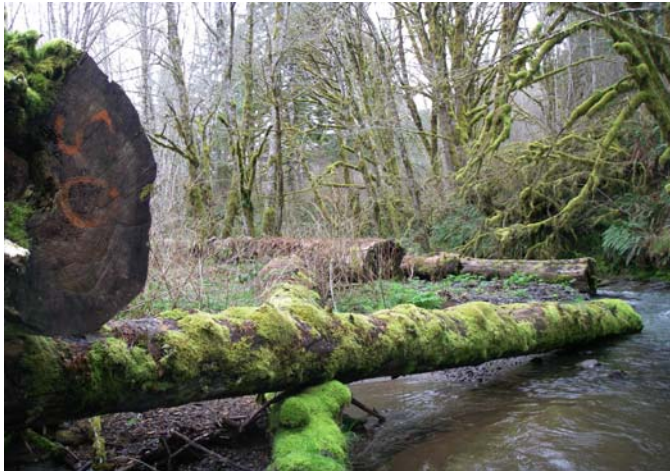
Unit 25 - Habitat structure within left bank influencing active channel.

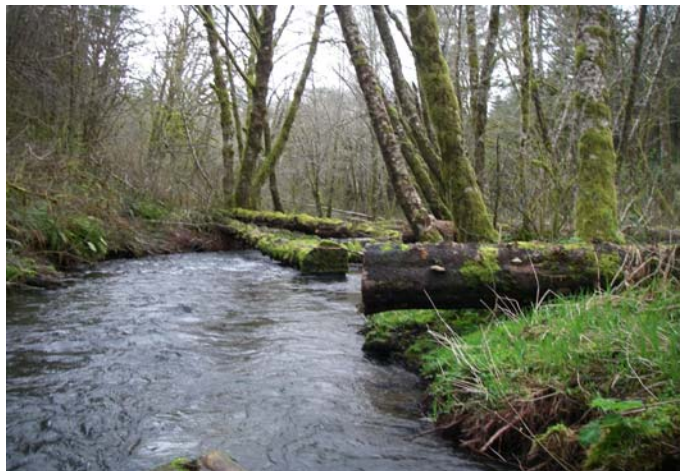
Unit 25 - Downstream view of habitat structure.

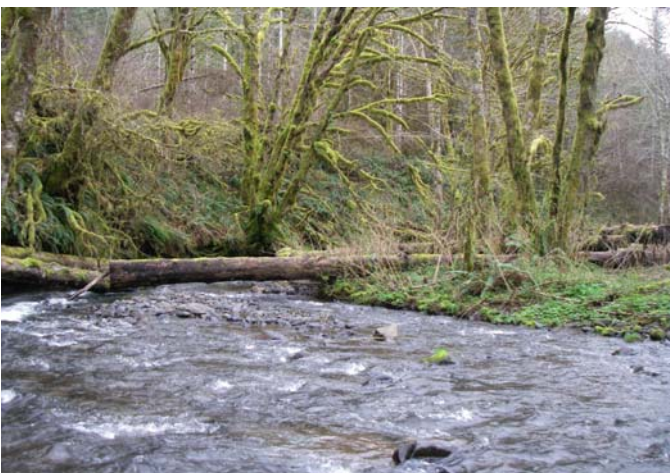
Unit27 - Downstream view of habitat structure at end of survey.
