**ODFW AQUATIC INVENTORY PROJECT
RESTORATION MONITORING
STREAM HABITAT REPORT**

STREAM: CRAB CREEK
 GCG: 2-MC
 SITE ID: 20
 BASIN: ALSEA
 TREATMENT DATE: 2002
 SURVEY DATE: 3/10/2009
 SURVEY CREW: David Jones / Ryan Emig
 USGS MAPS: FIVE RIVERS
 ECOREGION: Mid-Coastal Sedimentary
 REPORT PREPARED BY: Matt Strickland / Sharon Tippery / Charles Stein

REACH: 1 LOCATION: T15S-R10W-S12SE

Crab Creek (MC-20) 2009 Winter Habitat Survey Photographs

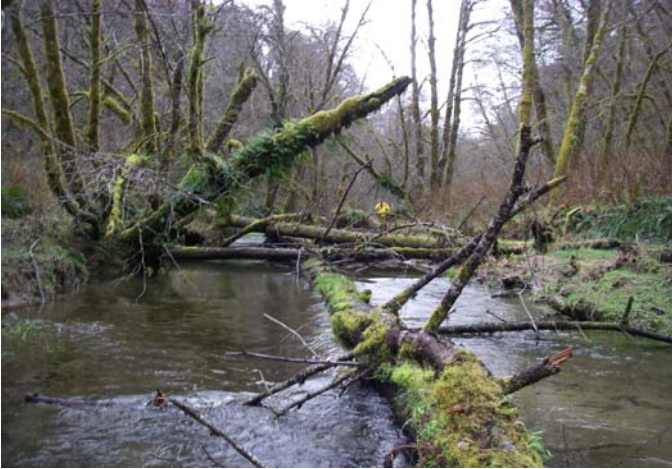
Unit 1 - Looking upstream at pool at the start of the survey.

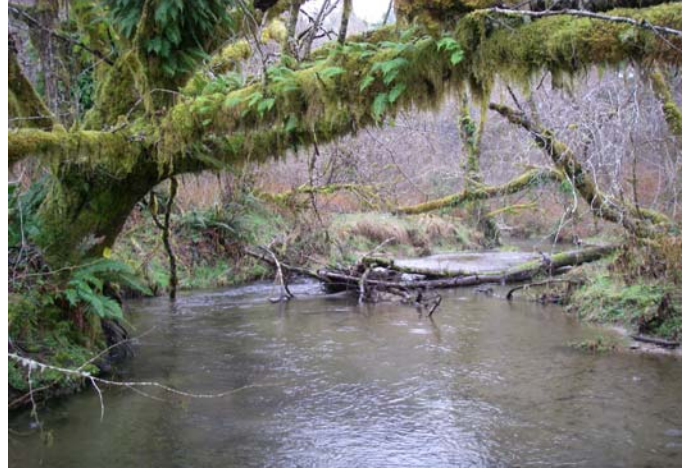
Looking upstream at the end of the survey.
