**ODFW AQUATIC INVENTORY PROJECT
RESTORATION MONITORING
STREAM HABITAT REPORT**

STREAM: BIG ELK CREEK SITE 1
 GCG: 2-MC
 SITE ID: 399
 BASIN: YAQUINA
 TREATMENT DATE: 2008
 SURVEY DATE: 1/26/2009
 SURVEY CREW: Matt Strickland / Charlie Stein
 USGS MAPS: ELK CITY
 ECOREGION: Mid-Coastal Sedimentary
 REPORT PREPARED BY: Matt Strickland / Sharon Tippery / Charles Stein

Big Elk Creek Site 1 (MC-399) 2009 Winter Habitat Survey Photographs

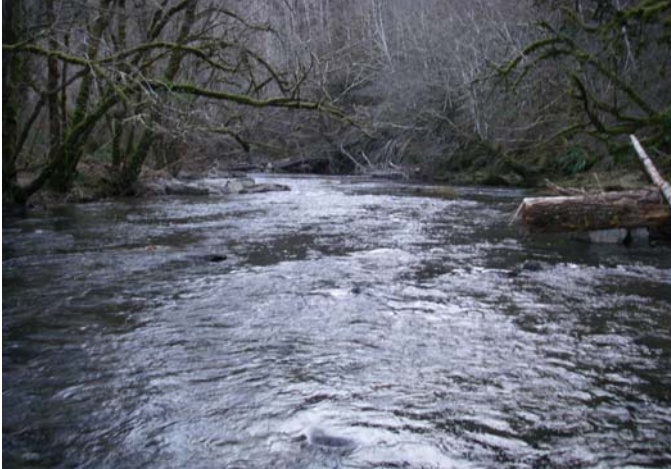
Upstream view of the survey reach.

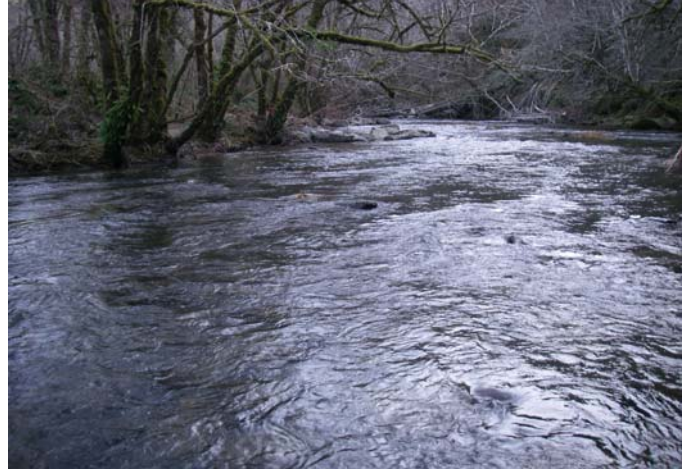
Upstream view of placed boulders on left bank.

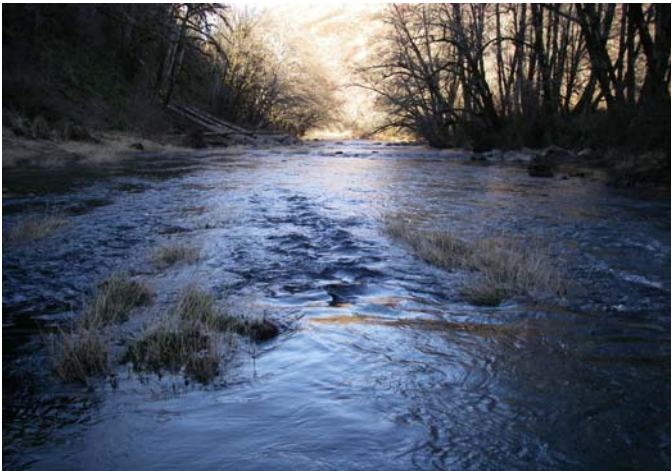
Downstream view of the survey reach.

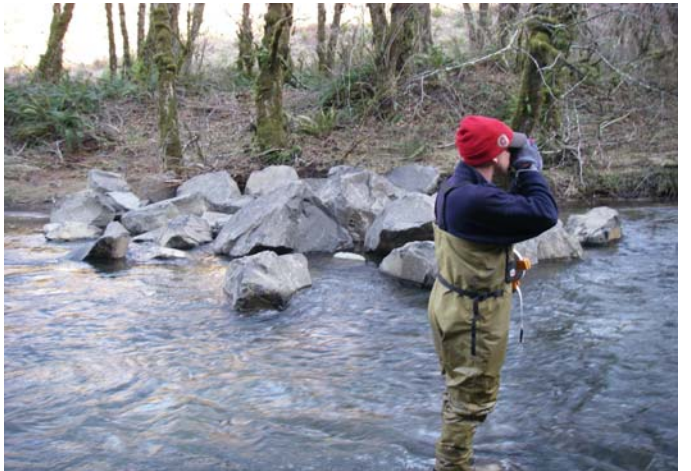
Placed boulders for habitat structure.

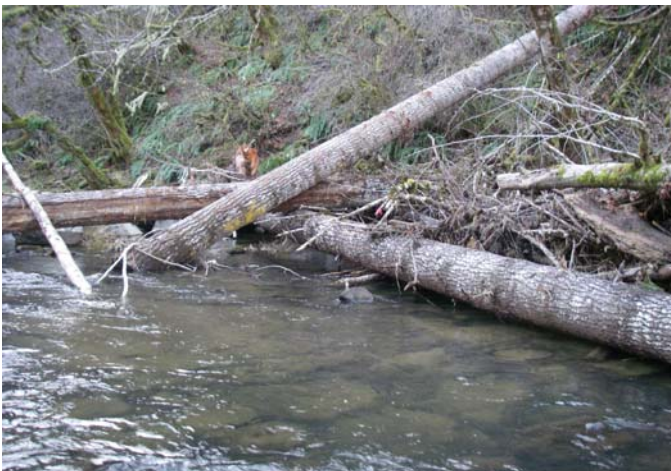
Large wood and boulder placement.
