**ODFW AQUATIC INVENTORY PROJECT  
RESTORATION MONITORING  
STREAM HABITAT REPORT**

STREAM: BIG ELK CREEK SITE 2  
 GCG: 2-MC  
 SITE ID: 400  
 BASIN: YAQUINA  
 TREATMENT DATE: 2008  
 SURVEY DATE: 1/26/2009  
 SURVEY CREW: Matt Strickland / Charlie Stein  
 USGS MAPS: HARLAN  
 ECOREGION: Mid-Coastal Sedimentary  
 REPORT PREPARED BY: Matt Strickland / Sharon Tippery / Charles Stein

**Big Elk Creek Site 2 (MC-400) 2009 Winter Habitat Survey Photographs**

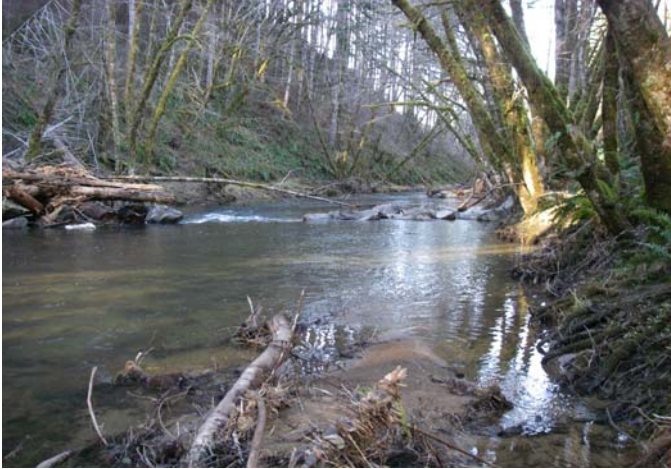
Downstream view of placed large wood and boulders.

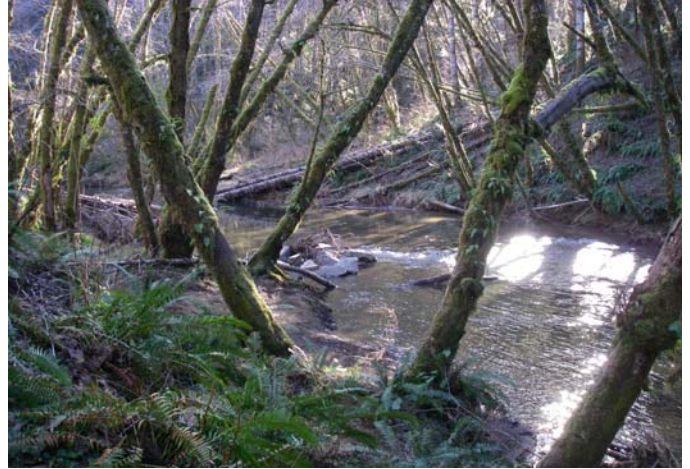
Jackass Creek confluence on right bank upstream of large wood.

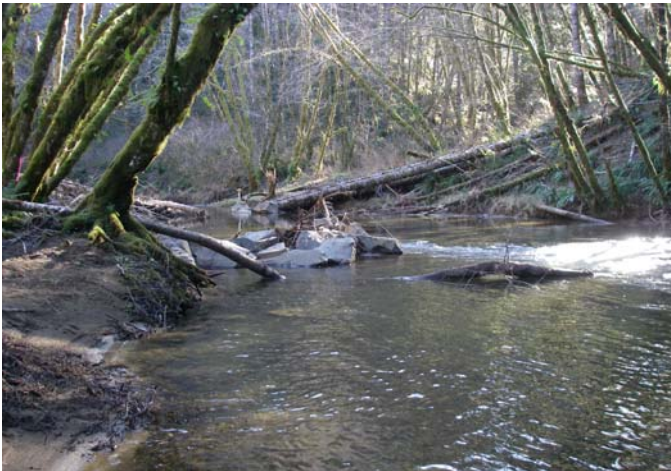
Upstream view of boulder and large wood placement.

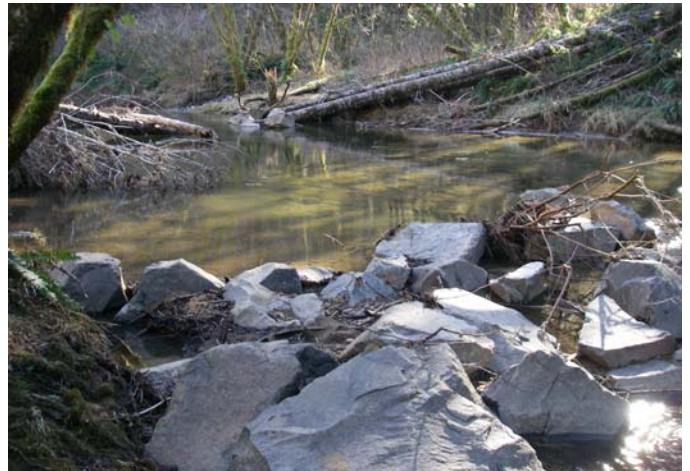
Sediment accumulation around placed boulders.

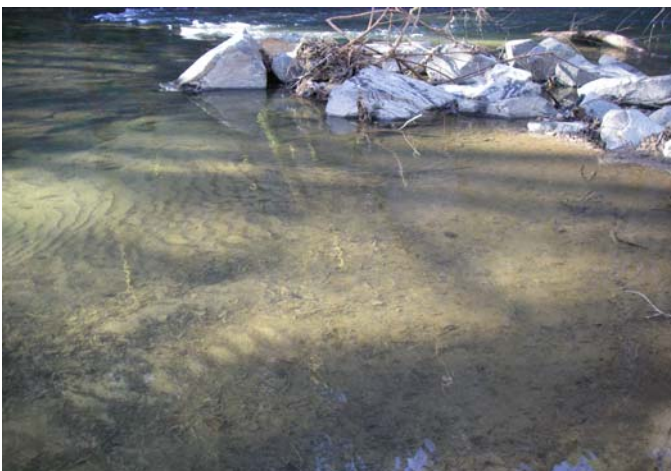
Sediment accumulation.
