**ODFW AQUATIC INVENTORY PROJECT
RESTORATION MONITORING
STREAM HABITAT REPORT**

STREAM: CEDAR CREEK
 GCG: 5-SC
 SITE ID: 128
 BASIN: ELK
 TREATMENT DATE: 2002
 SURVEY DATE: 4/1/2009
 SURVEY CREW: David Jones / Ryan Emig
 USGS MAPS: CAPE BLANCO
 ECOREGION: Coastal Lowlands
 REPORT PREPARED BY: Matt Strickland / Sharon Tippery / Charles Stein

Cedar Creek (SC-128) 2009 Winter Habitat Survey Photographs

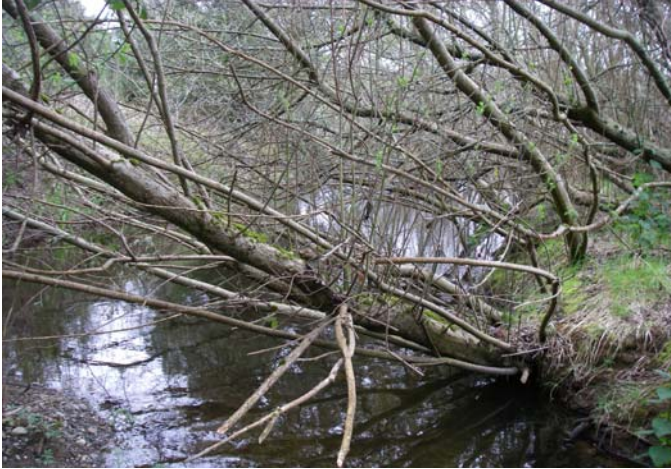
Upstream view of the Cedar Creek willow riparian near start of survey.

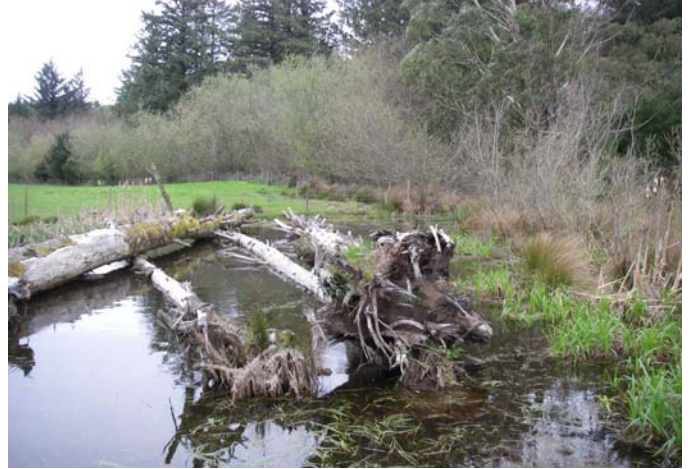
Off-channel wetland habitat with placed logs.

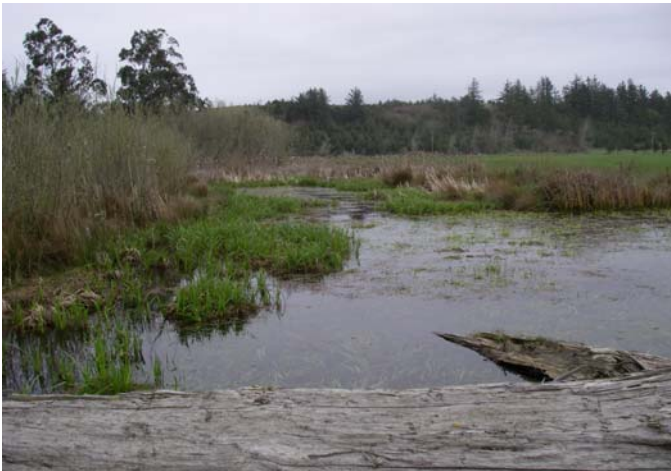
Wetland/pond interacting with active channel near unit 14.

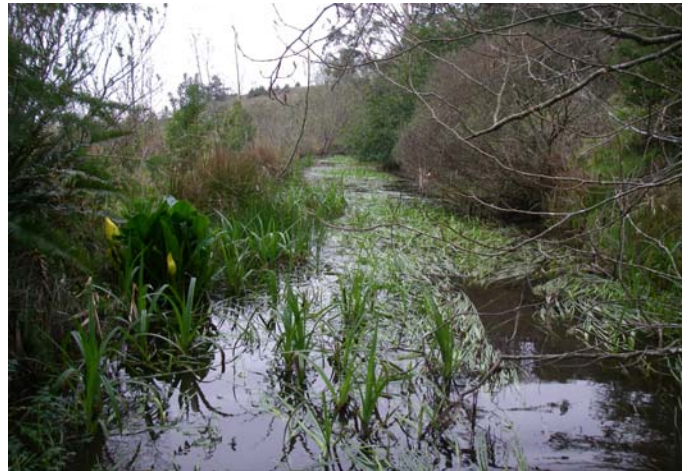
Off-channel wetland habitat near unit 14.

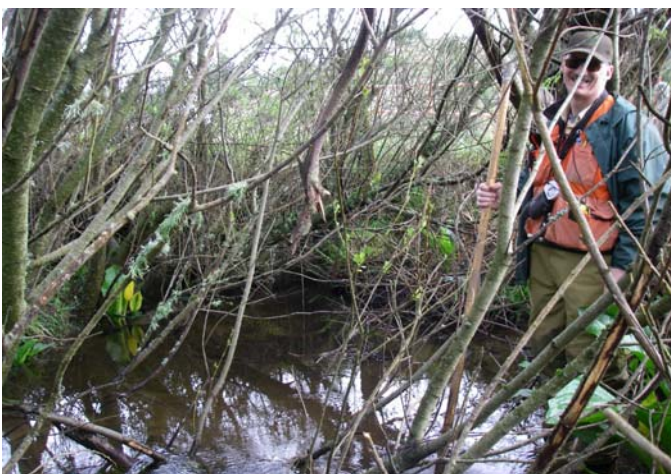
Willow dominated riparian near end of survey.
