**ODFW AQUATIC INVENTORY PROJECT
RESTORATION MONITORING
STREAM HABITAT REPORT**

STREAM: JACK CREEK
 GCG: 5-SC
 SITE ID: 188
 BASIN: CHETCO
 TREATMENT DATE: 2003
 SURVEY DATE: 4/14/2009
 SURVEY CREW: David Jones / Ryan Emig
 USGS MAPS: MT EMILY
 ECOREGION: Southern Oregon Coastal Mountain
 REPORT PREPARED BY: Matt Strickland / Sharon Tippery / Charles Stein

REACH: 1 LOCATION: T41S-R13W-S02NW

Jack Creek (SC-188) 2009 Winter Habitat Survey Photographs

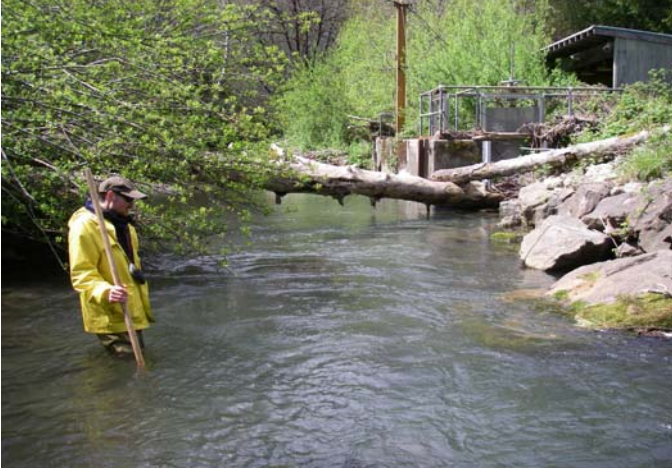
Downstream view near the start of the survey.

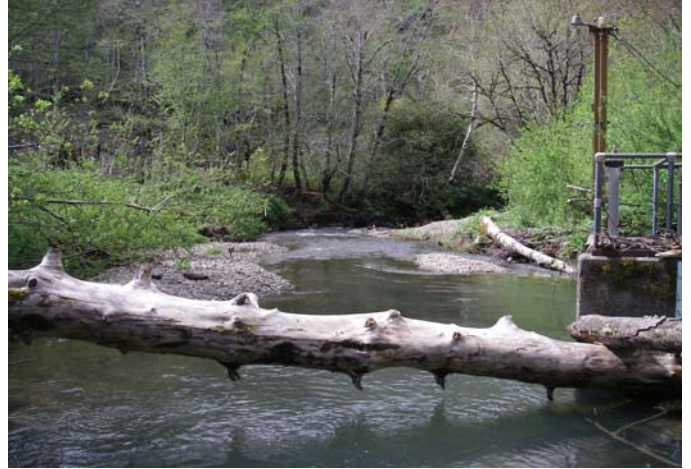
Downstream view of placed large wood habitat structure.
