**ODFW AQUATIC INVENTORY PROJECT
RESTORATION MONITORING
STREAM HABITAT REPORT**

STREAM: BRUSH CREEK SITE B
 GCG: 5-SC
 SITE ID: 191
 BASIN: OCEAN
 TREATMENT DATE: 2003
 SURVEY DATE: 4/14/2009
 SURVEY CREW: David Jones / Ryan Emig
 USGS MAPS: PORT ORFORD
 ECOREGION: Coastal Uplands
 REPORT PREPARED BY: Matt Strickland / Sharon Tippery / Charles Stein

Brush Creek Site B (SC-191) 2009 Winter Habitat Survey Photographs

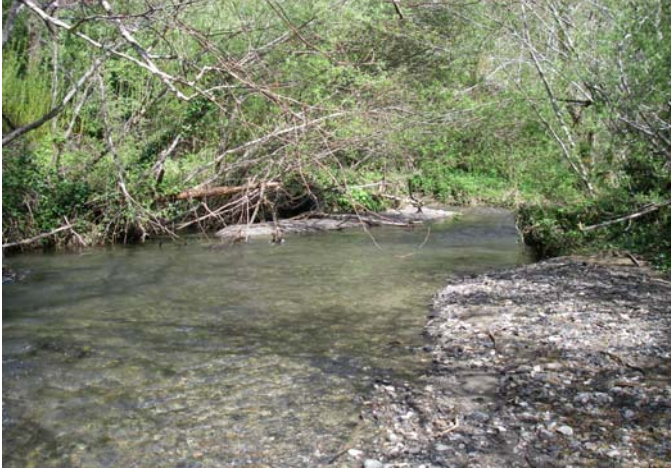
Upstream view of Brush Creek Site B near the start of the survey.

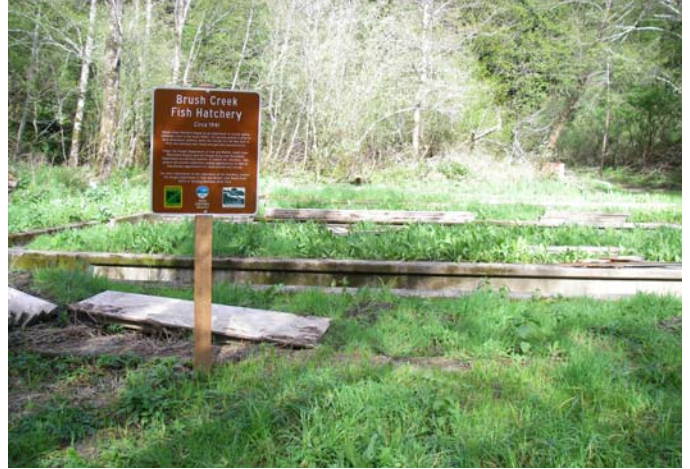
Partially deconstructed Brush Creek Hatchery.

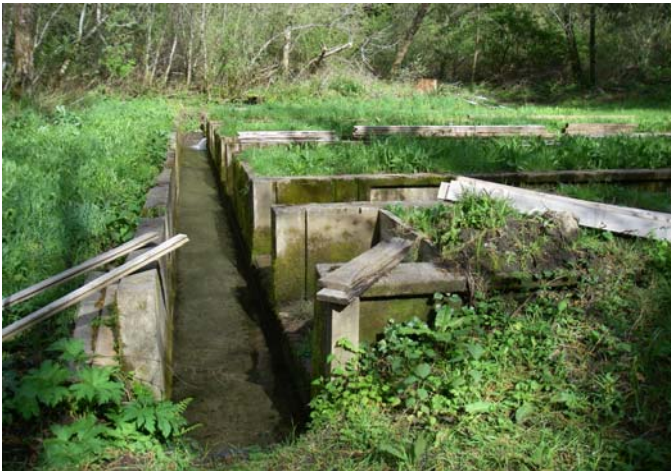
Raceways at Brush Creek Hatchery.

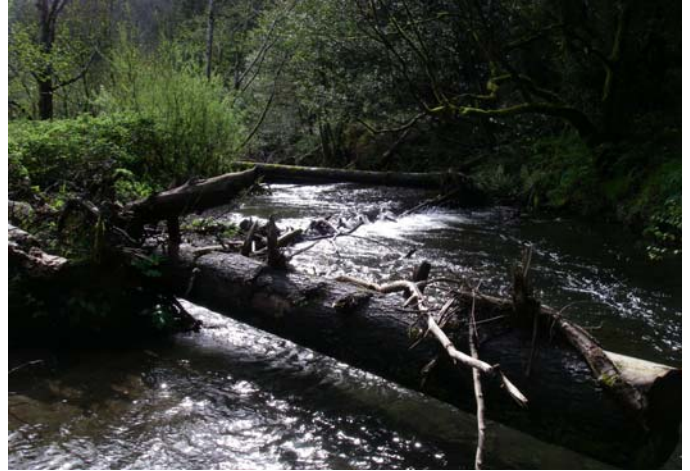
Upstream view of large wood placements for habitat structures.

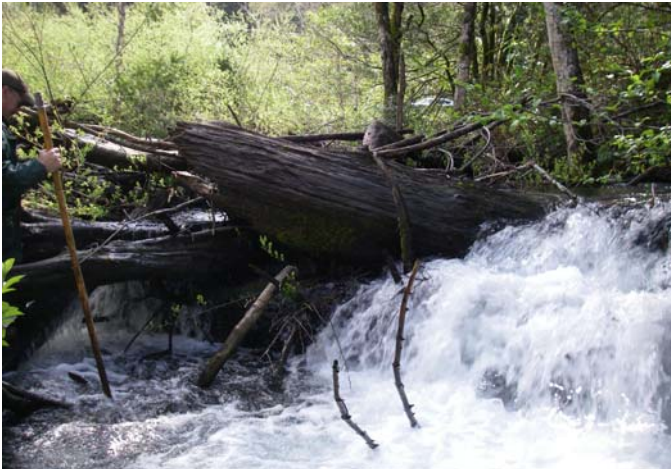
Step over debris jam near end of survey.

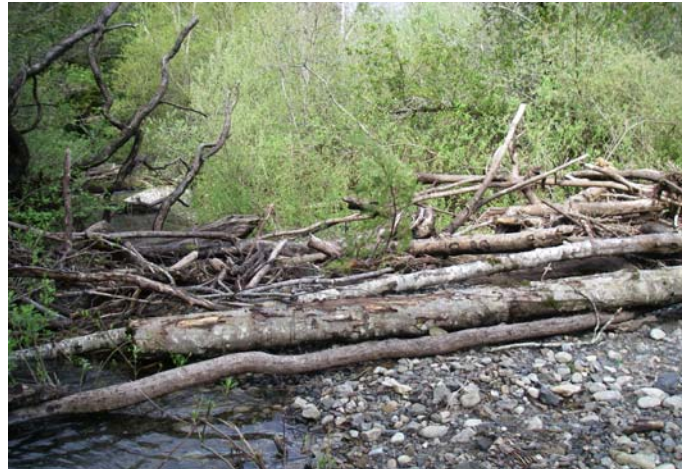
Accumulated woody debris near upper end of debris jam creating multiple channels.

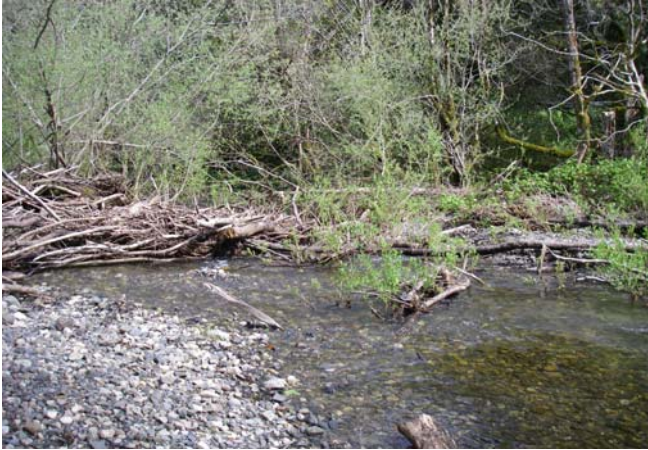
Accumulated woody debris near upper end of debris jam.

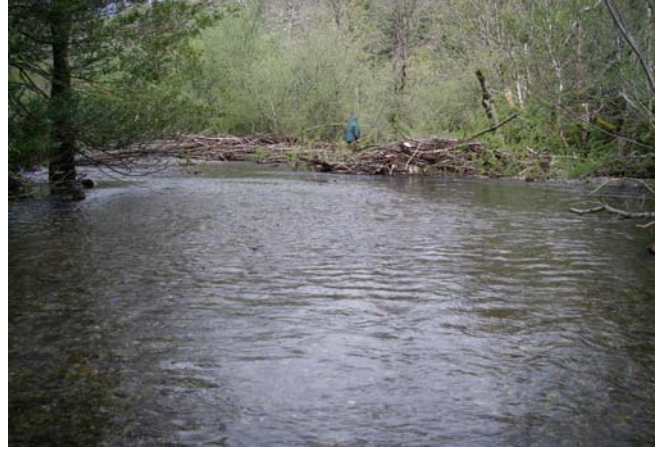
Upper end of debris jam and multiple channels near the end of the survey

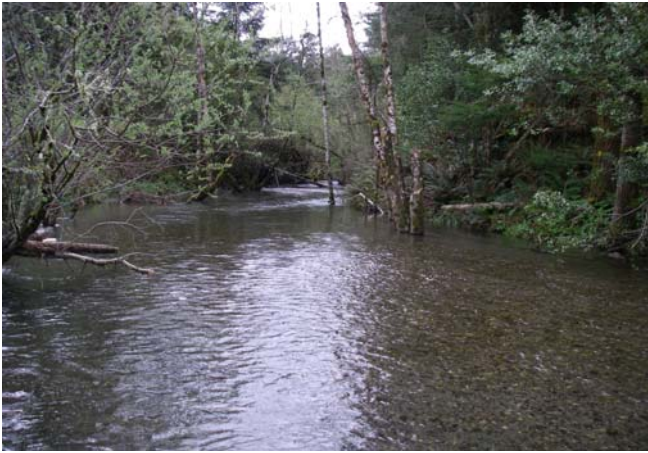
Flooded riparian due to large debris jam near end of survey.
